Appendix A17.1 Arboricultural Impact Assessment

Arbor-Care Ltd (Professional Consulting Tree Service) was retained by Arup Consulting Engineers on behalf of the National Transport Authority (NTA) to undertake an Arboricultural Impact Assessment, and a Tree Protection Plan identifying the trees, groups of trees or hedgerows that may be impacted on by the BusConnects Core Bus Corridor. The surveyed trees contained within this report are located within or adjacent to the Templeogue / Rathfarnham to City Centre Core Bus Corridor Scheme (Figure 1 below) (hereinafter referred to as "The Proposed Scheme"). The objective of the impact assessment was to identify the areas that contained trees, groups of trees or hedgerows, and to ensure where practicable that these areas would be retained and to identify the trees that are to be removed to facilitate the Proposed Scheme.

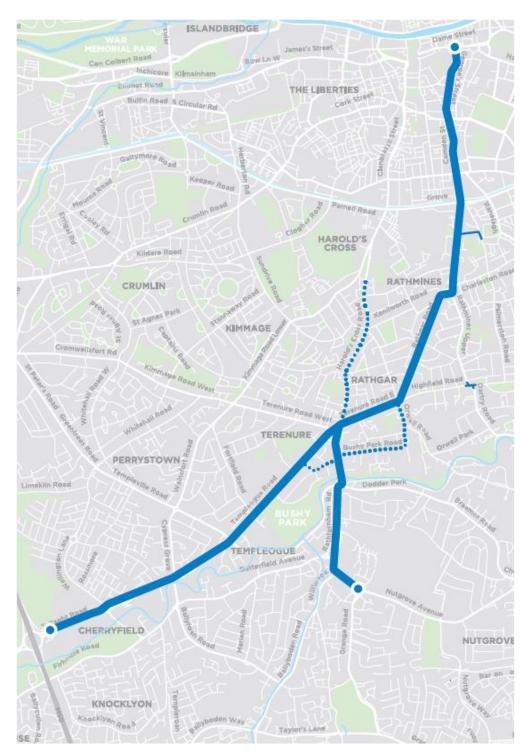
Figure 1: Proposed Route Corridor

The Templeogue to Terenure commences on the Tallaght Road, east of the M50 interchange. From here, the CBC is routed via the R137 along Tallaght Road and Templeogue Road, through Templeogue Village, to Terenure Cross, where it joins the Rathfarnham to city centre section.

The Rathfarnham to City Centre section commences on the R821 Grange Road at the junction with Nutgrove Avenue. The CBC is routed along Grange Road, Rathfarnham Road, Terenure Road East, Rathgar Road, Rathmines Road Lower, Richmond Street South, Camden Street Upper and Lower, and Wexford Street to its junction with Kevin Street Lower and Cuffe Street where priority bus lanes end. From Cuffe Street to Dame Street along Redmond's Hill, Aungier Street and South Great George's Street, the route will involve a traffic lane and a cycle track in both directions where it will join the existing traffic management regime in the city centre. Alternative cycle facilities are also proposed on Terenure Road North and Harold's Cross Road and on Wasdale Park, Wasdale Grove, Victoria Road, Zion Road and Orwell Road.

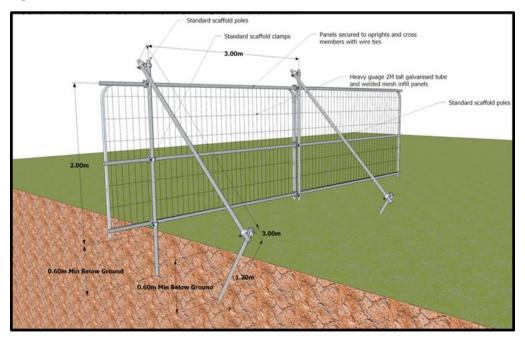
Figure 3: Default specification for tree protection barrier in accordance with BS5837:2012 figure 2

Default Specification:

Fencing shall be constructed with robust vertical and horizontal scaffold framework with weldmesh panels firmly attached in accordance with BS 5837:2012 Figure 2. Vertical support poles and bracing poles must be located with care to avoid underground utility services and will be sited to avoid the structural roots of retained trees. Where driven supports are not practicable due to the presence of roots or underground utilities block trays, counterweights or equivalent can be utilised.

Alternative equivalent robust and immovable fencing specification including site hoarding will also be appropriate.

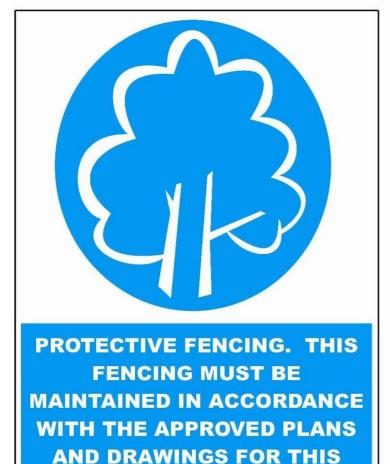
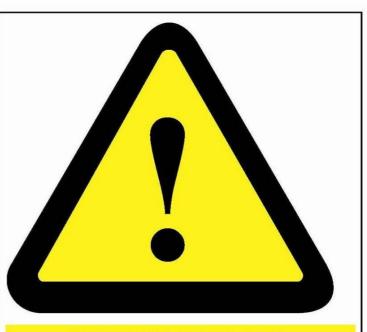
Tree Protection Signage (Example)

TREE PROTECTION AREA KEEP OUT !

(TOWN & COUNTRY PLANNING ACT 1990) TREES ENCLOSED BY THIS FENCE ARE PROTECTED BY PLANNING CONDITIONS AND/OR ARE THE SUBJECTS OF A TREE PRESERVATION ORDER. CONTRAVENTION OF A TREE PRESERVATION ORDER MAY LEAD TO CRIMINAL PROSECUTION
